## INFRASTRUCTURE CONDITION SURVEY

RIVER OAKS LANDING  
HOMEOWNERS ASSOCIATION  
ORANGE COUNTY, FLORIDA

UES PROJECT No. 0110.2301090.0000  
UES REPORT No. 2047277

**October 18, 2023**

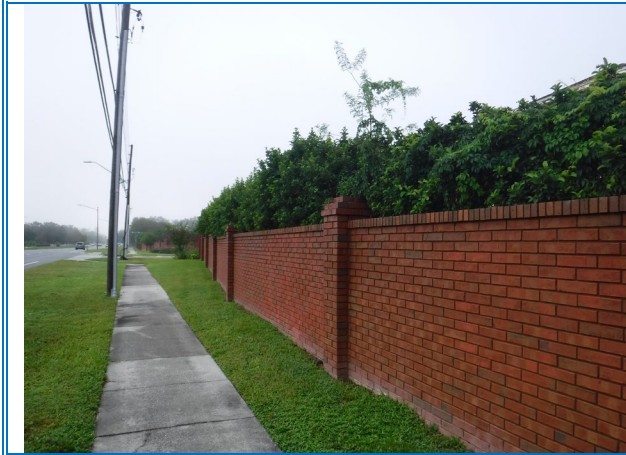
OBSERVATION 1

<b>OBSERVATION NO.</b>	<b>OBSERVATIONS</b>	<b>CORRECTIVE RECOMMENDATION</b>
1	Screen Wall – Vegetation growth against wall	Remove, prune, or limb as needed
2	Screen Wall – wall panel end (at signage) is leaning/rotating	Enlist licensed wall contractor to examine/repair
3	Screen Wall – Vegetation growth against wall	Remove, prune, or limb as needed
4	Screen Wall – broken column foundation	Enlist licensed wall contractor to examine/repair
5	Screen Wall – large tree limbs grown against wall	Remove, prune, or limb as needed
6	Roadway/Gutter – frequently holding water, impacting roadway +/-20 lf	Remove and replace at proper grade
7	Roadway – sanitary manhole apron failing	Remove and replace
8	Sidewalk – stub toes +/-68 sf	Remove and replace or grinding
9	Roadway/Gutter – frequently holding water, impacting roadway +/-14 lf, roadway patch settling +/-112 sf	Remove and replace at proper grade, enlist specialty contractor to inspect utility/pipe for leaks

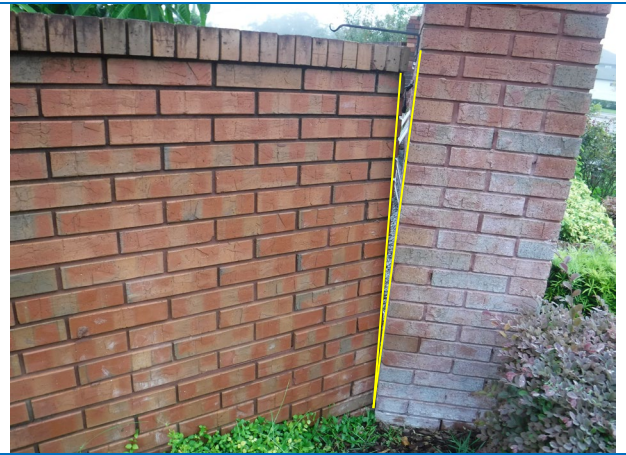
OBSERVATION 2

The signage walls and screen walls are accessible from the outside only and were observed to be in relatively good condition and appear to have been recently power washed. There were no overt indications of settlement, rotation, or distress observed, with the exception of a ‘leaning’ wall panel at the north community sign and damaged column foundation south of the entrance. A licensed wall contractor should be enlisted to examine these locations and make the necessary repairs. The intended service life and actual useful life is dependent upon regular maintenance, and outside influences that may attribute to subsidence, rotation, or degradation. The walls and signage should be pressure washed at least every 3 years to prevent advanced staining and deterioration of coatings, and sealed (especially the top-side surfaces) at least every 6 years. Mortar joint re-tooling should be performed when warranted to inhibit moisture related damage and degradation. Large trees and roots that may affect the wall should be limbed and/or removed. Homeowners should routinely inspect their respective portions of the walls for any visible issues or conditions and proactively address removing, pruning, or limbing plantings that may affect the walls.

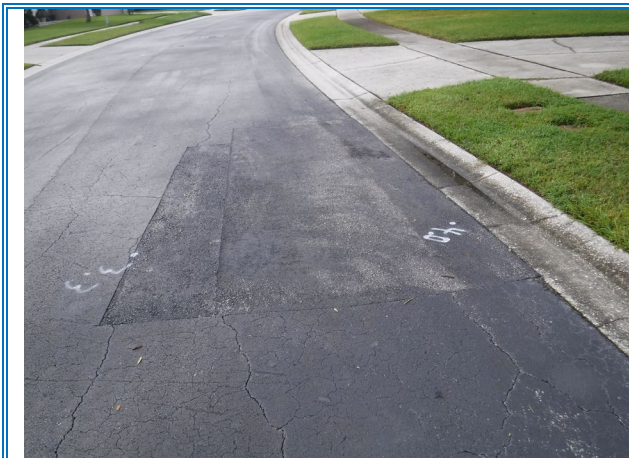
OBSERVATION 9

has been previously patched and that appears to have continuing surface settlement/deformation (Observation #9) that we also recommend to have the pipe run inspected.

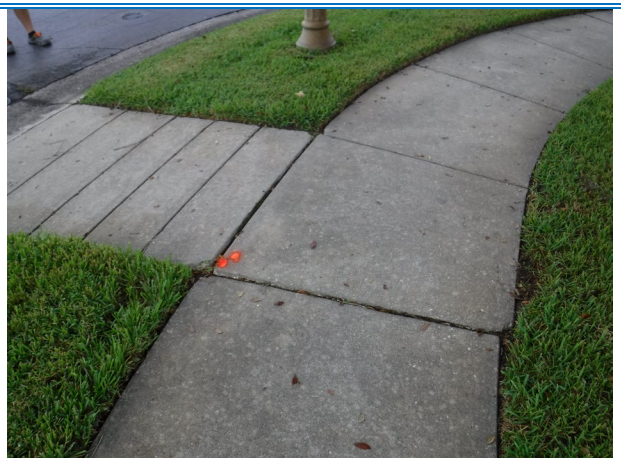
OBSERVATION 10

10	Sidewalk – stub toes +/-16 sf	Remove and replace or grinding
11	Roadway/Gutter – frequently holding water, impacting roadway +/-45 lf	Remove and replace at proper grade
12	Sidewalk – stub toes +/-16 sf	Remove and replace or grinding
13	Sidewalk – stub toes +/-16 sf	Remove and replace or grinding
14	Sidewalk – stub toes +/-20 sf	Remove and replace or grinding
15	Roadway/Gutter – frequently holding water, impacting roadway +/-20 lf	Remove and replace at proper grade
16	Roadway/Gutter – frequently holding water, impacting roadway +/-30 lf	Remove and replace at proper grade
17	Roadway/Gutter – frequently holding water, impacting roadway +/-45 lf	Remove and replace at proper grade
18	Storm Utility – worsening depressions over storm pipe run, no indication of erosion	Enlist specialty contractor to inspect utility/pipe for leaks
19	Wet Pond – segmental walls continued erosion, displacement	Maintain as necessary

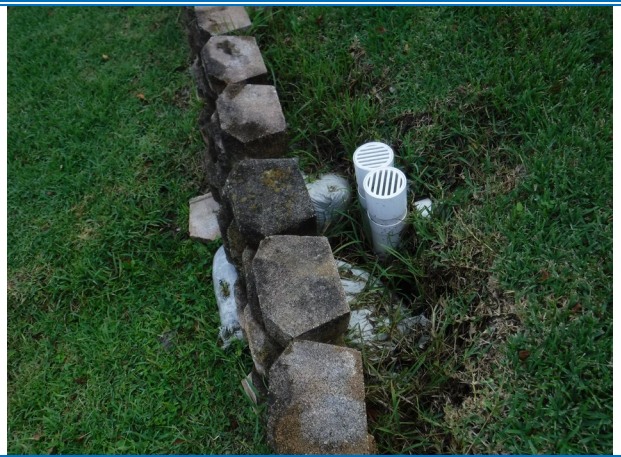
OBSERVATION 20

20	Wet Pond – segmental wall erosion from roof drains	Maintain/backfill as necessary
21	Storm Water – inlet structures buried/grown over	Uncover and relevel grade(s), examine for necessary repairs

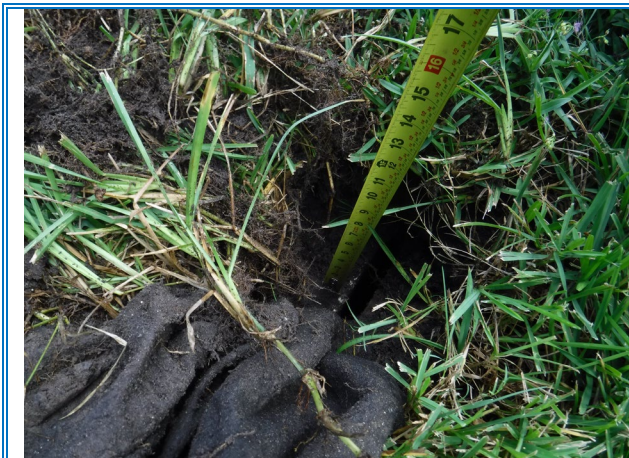
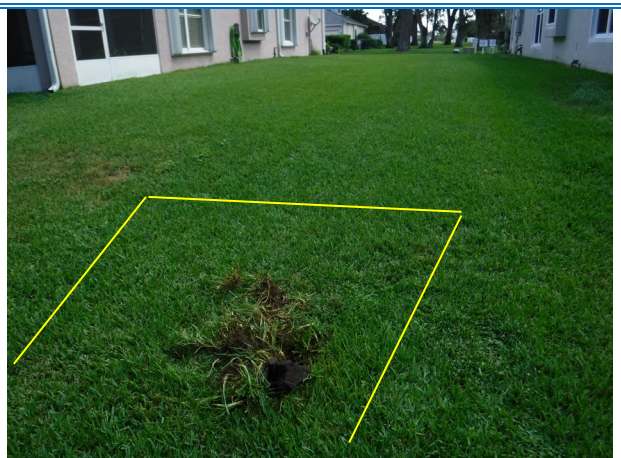
During this survey, we noted that there are (3) storm water structures (I-5A, I-5B, and I-5C) situated between yards along Lots 34 through 39 in the northwest quadrant of the community. We were only able to locate structure I-5A, and it was found buried approximately 1-foot below existing grade (Observation #'s 21a and 21b).

Additionally, we recommend that the (3) noted storm water structure inlets (Observation #21) be found and uncovered so that they can function as designed. Recovery of these structures will likely require some localized re-grading and sod placement.

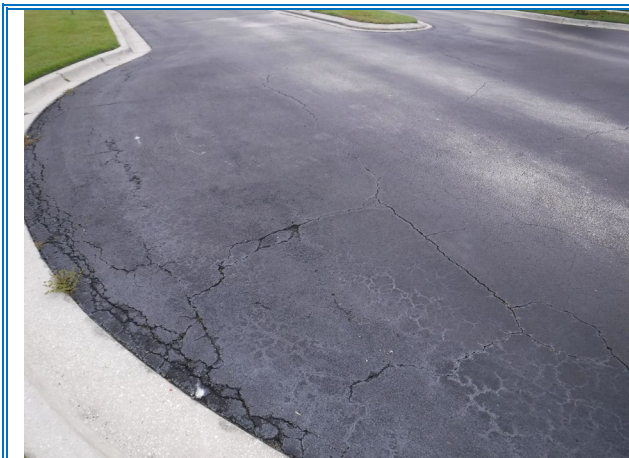
OBSERVATION A

<b>OBSERVATION NO.</b>	<b>GENERAL OBSERVATION</b>
A	Roadway – entrance area, edge failure, surface raveling and cracking
B	Roadway – surface raveling, alligator/micro cracking
C	Roadway - surface raveling, alligator/micro cracking, deformation
D	Roadway – surface raveling and widespread cracking
E	Dry Pond – generally well maintained
F	Wet Pond – generally well maintained
G	Wet Pond - control structure/weir appears to be in good condition
H	Storm Water – typically condition of storm water structure (manhole)
